## **McDONALD'S LOADING YARD IN MOSCOW**

Restoration of concrete loading yard of MacDonald's storage facilities in Moscow by SHIELDCRETE in a year of 2006.

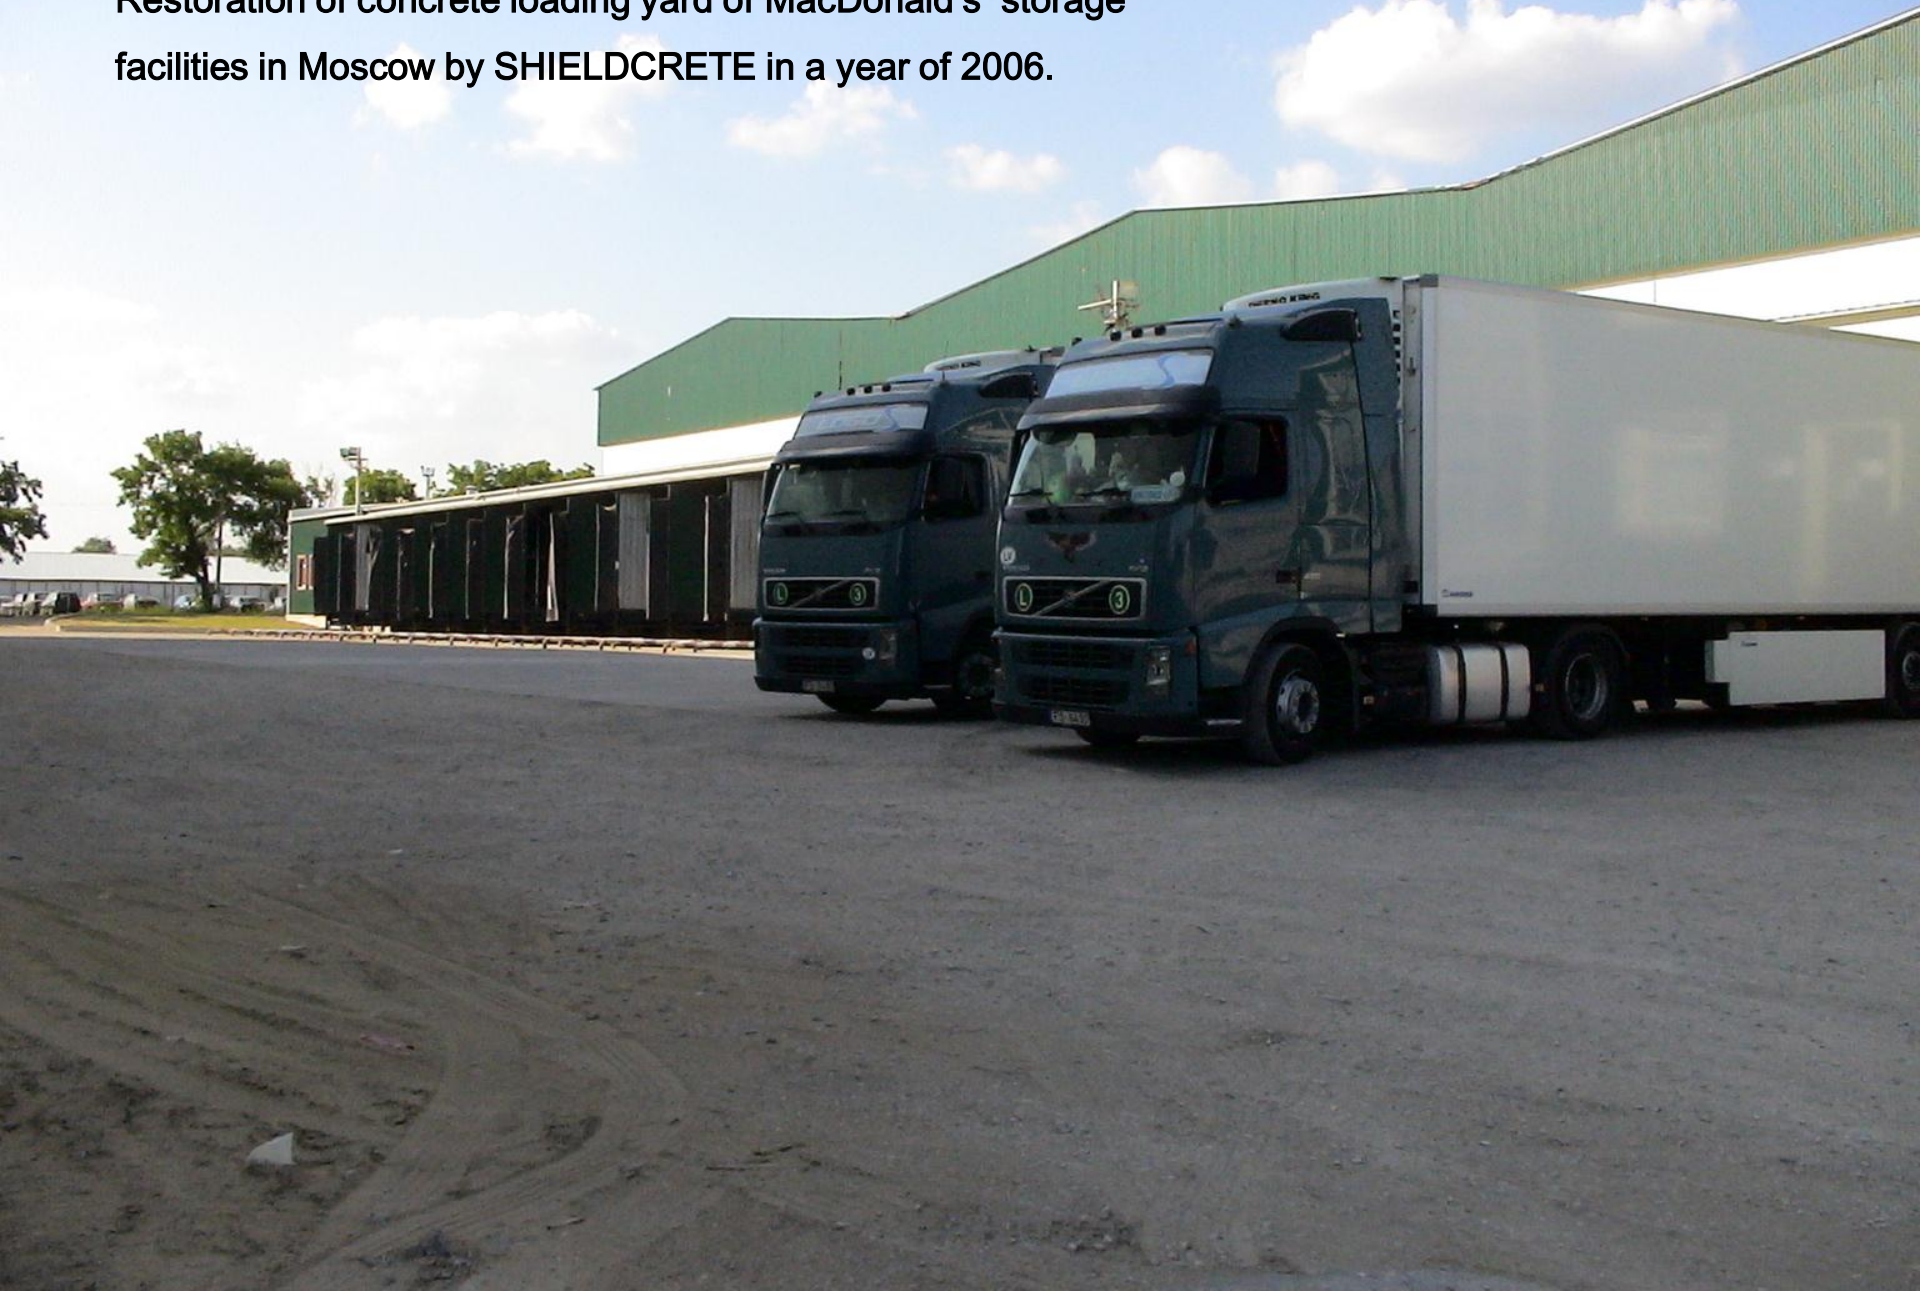
Excessive concrete abrasive wearing caused by the traffic of 40' containerized auto trucks and by the annual cycles of freeze-thaw concrete mass loss. The depth of concrete delamination is up to 2 cm eliminated concrete sacrificial layer and exposed wire mesh.

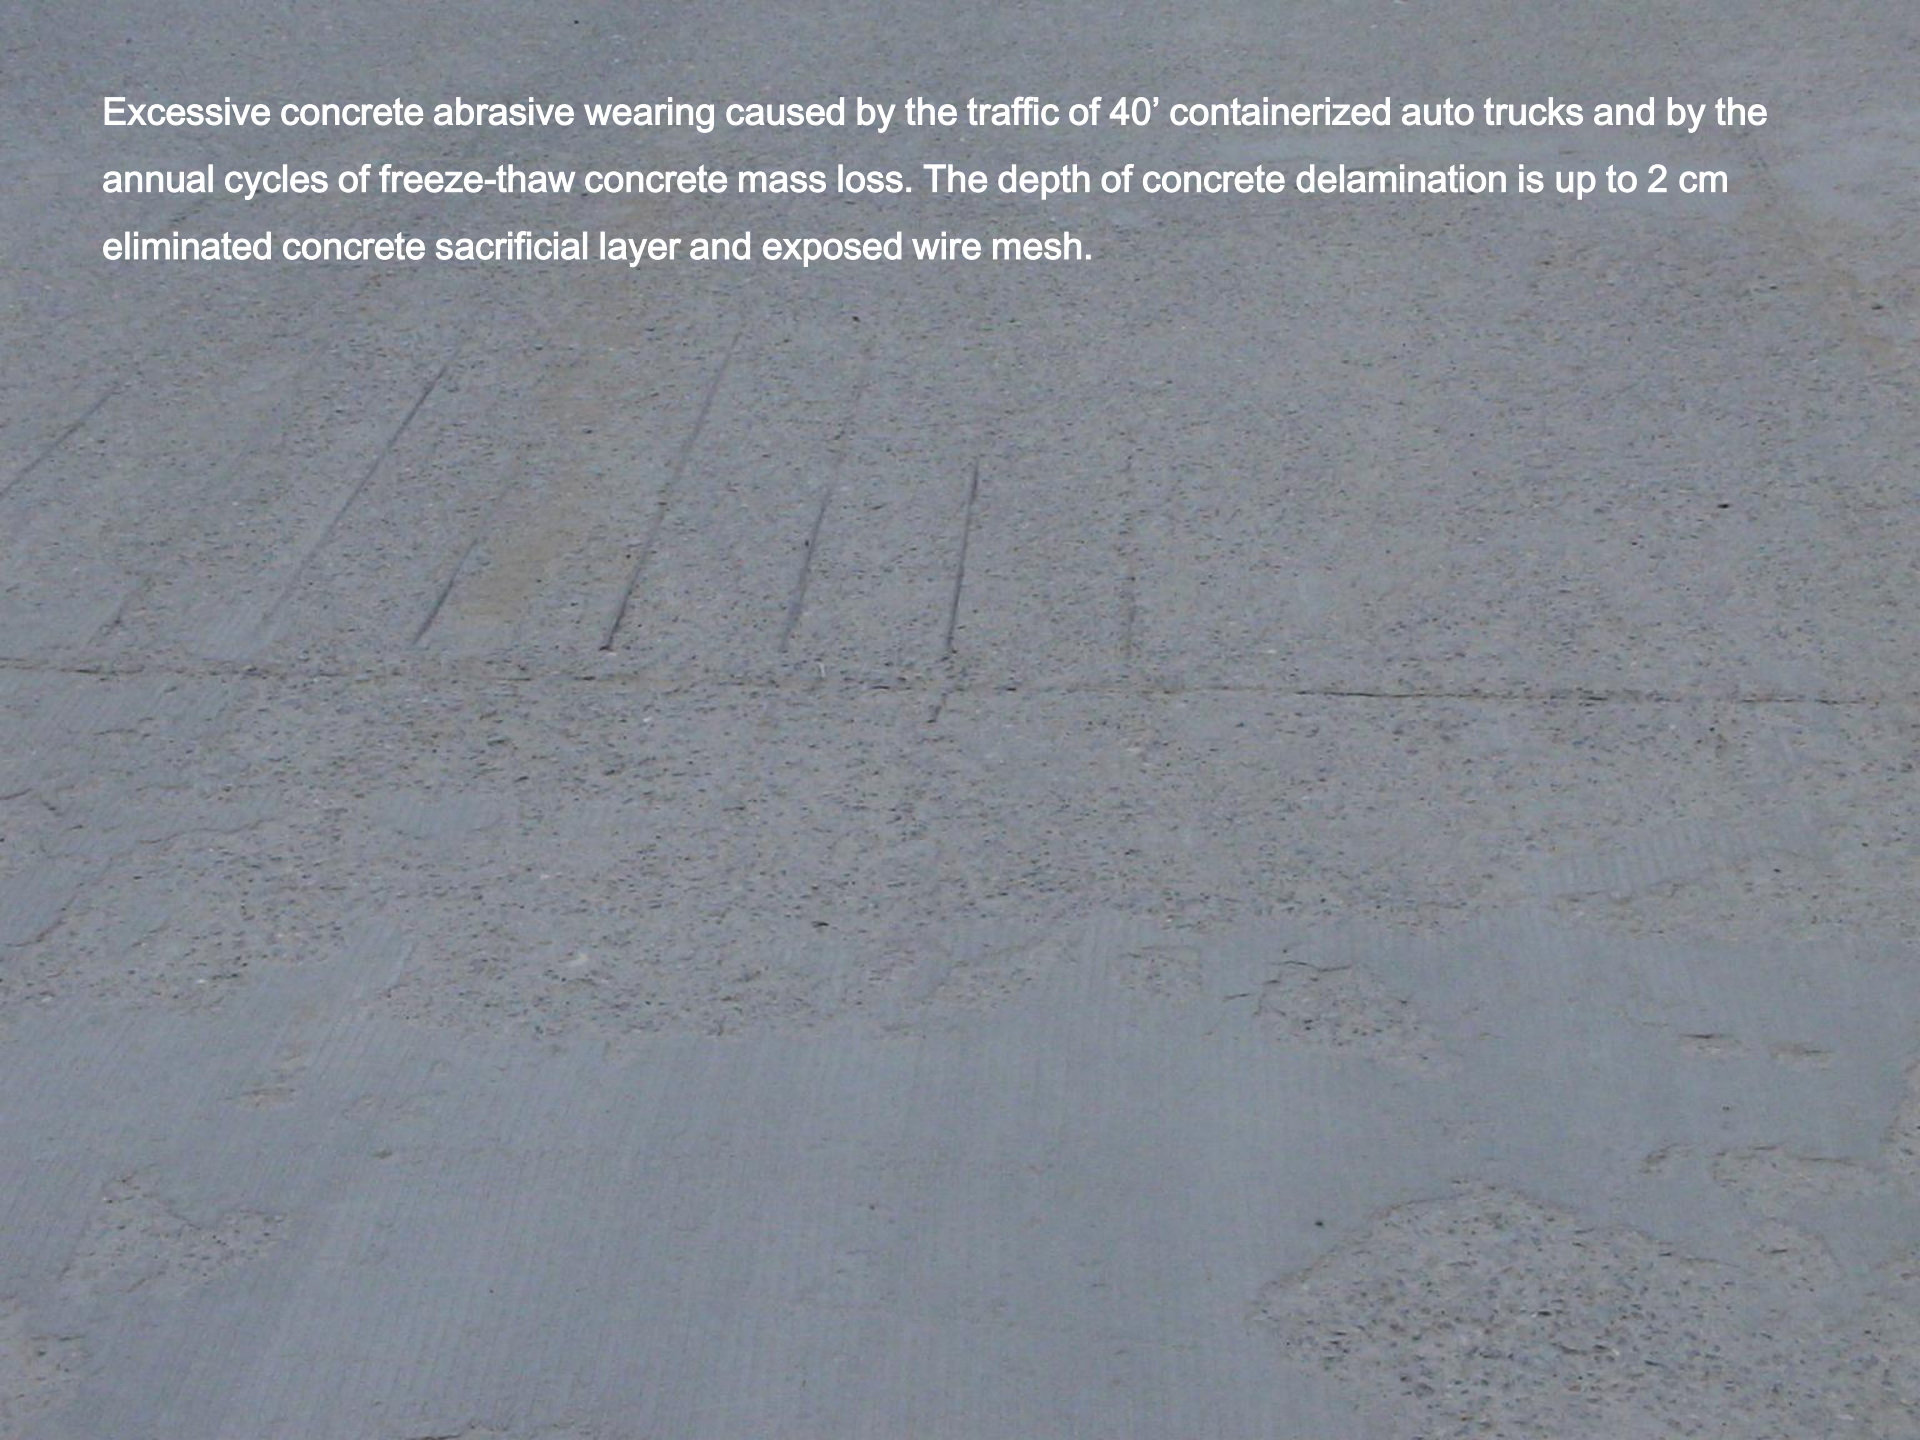
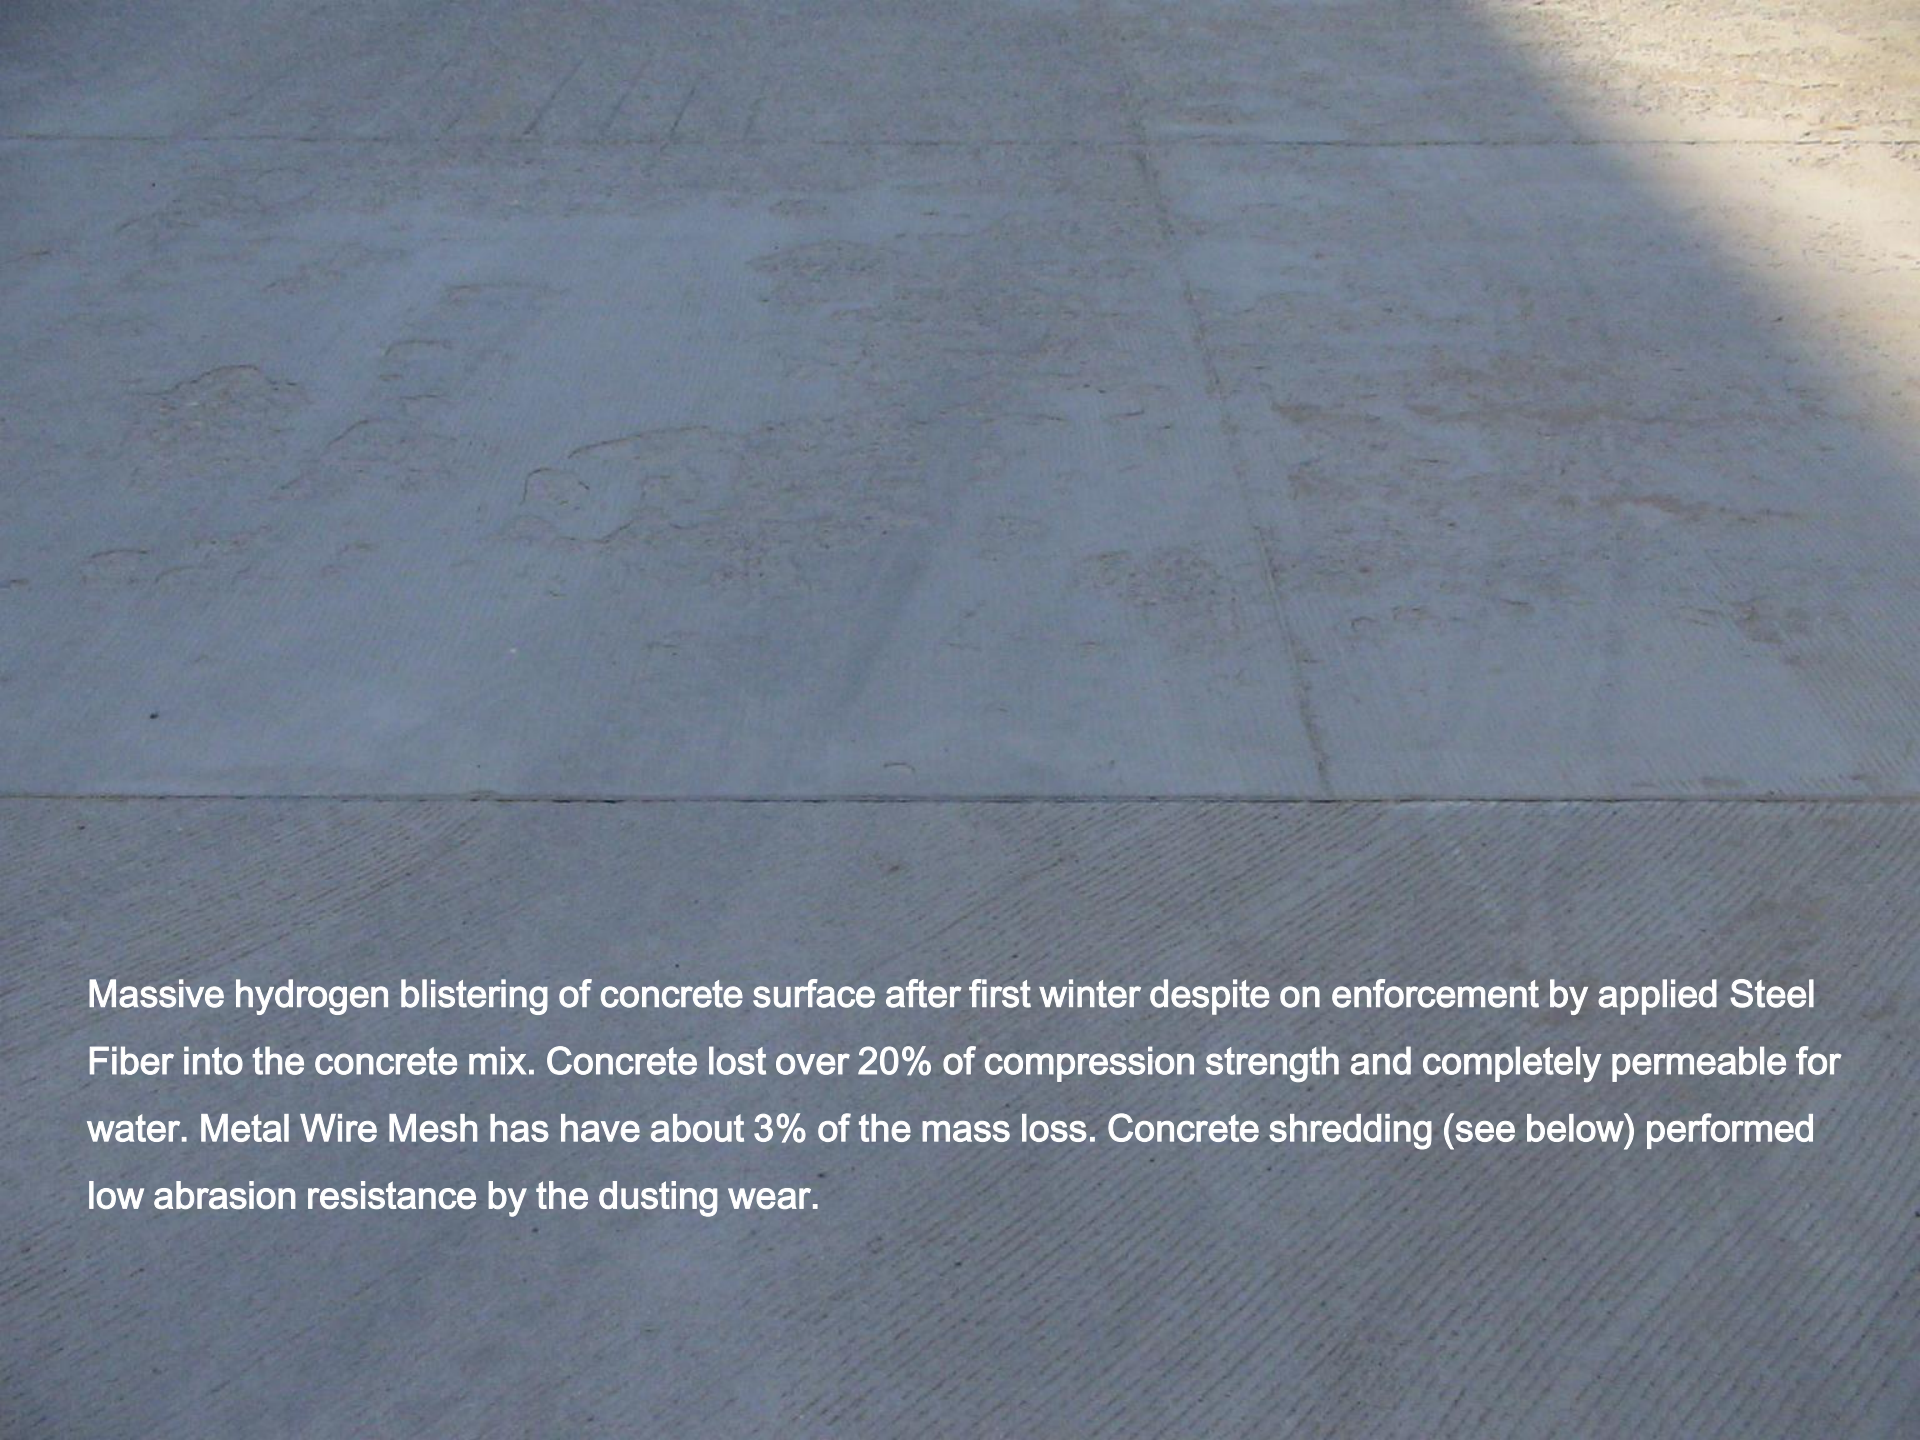
Massive hydrogen blistering of concrete surface after first winter despite on enforcement by applied Steel Fiber into the concrete mix. Concrete lost over 20% of compression strength and completely permeable for water. Metal Wire Mesh has have about 3% of the mass loss. Concrete shredding (see below) performed low abrasion resistance by the dusting wear.

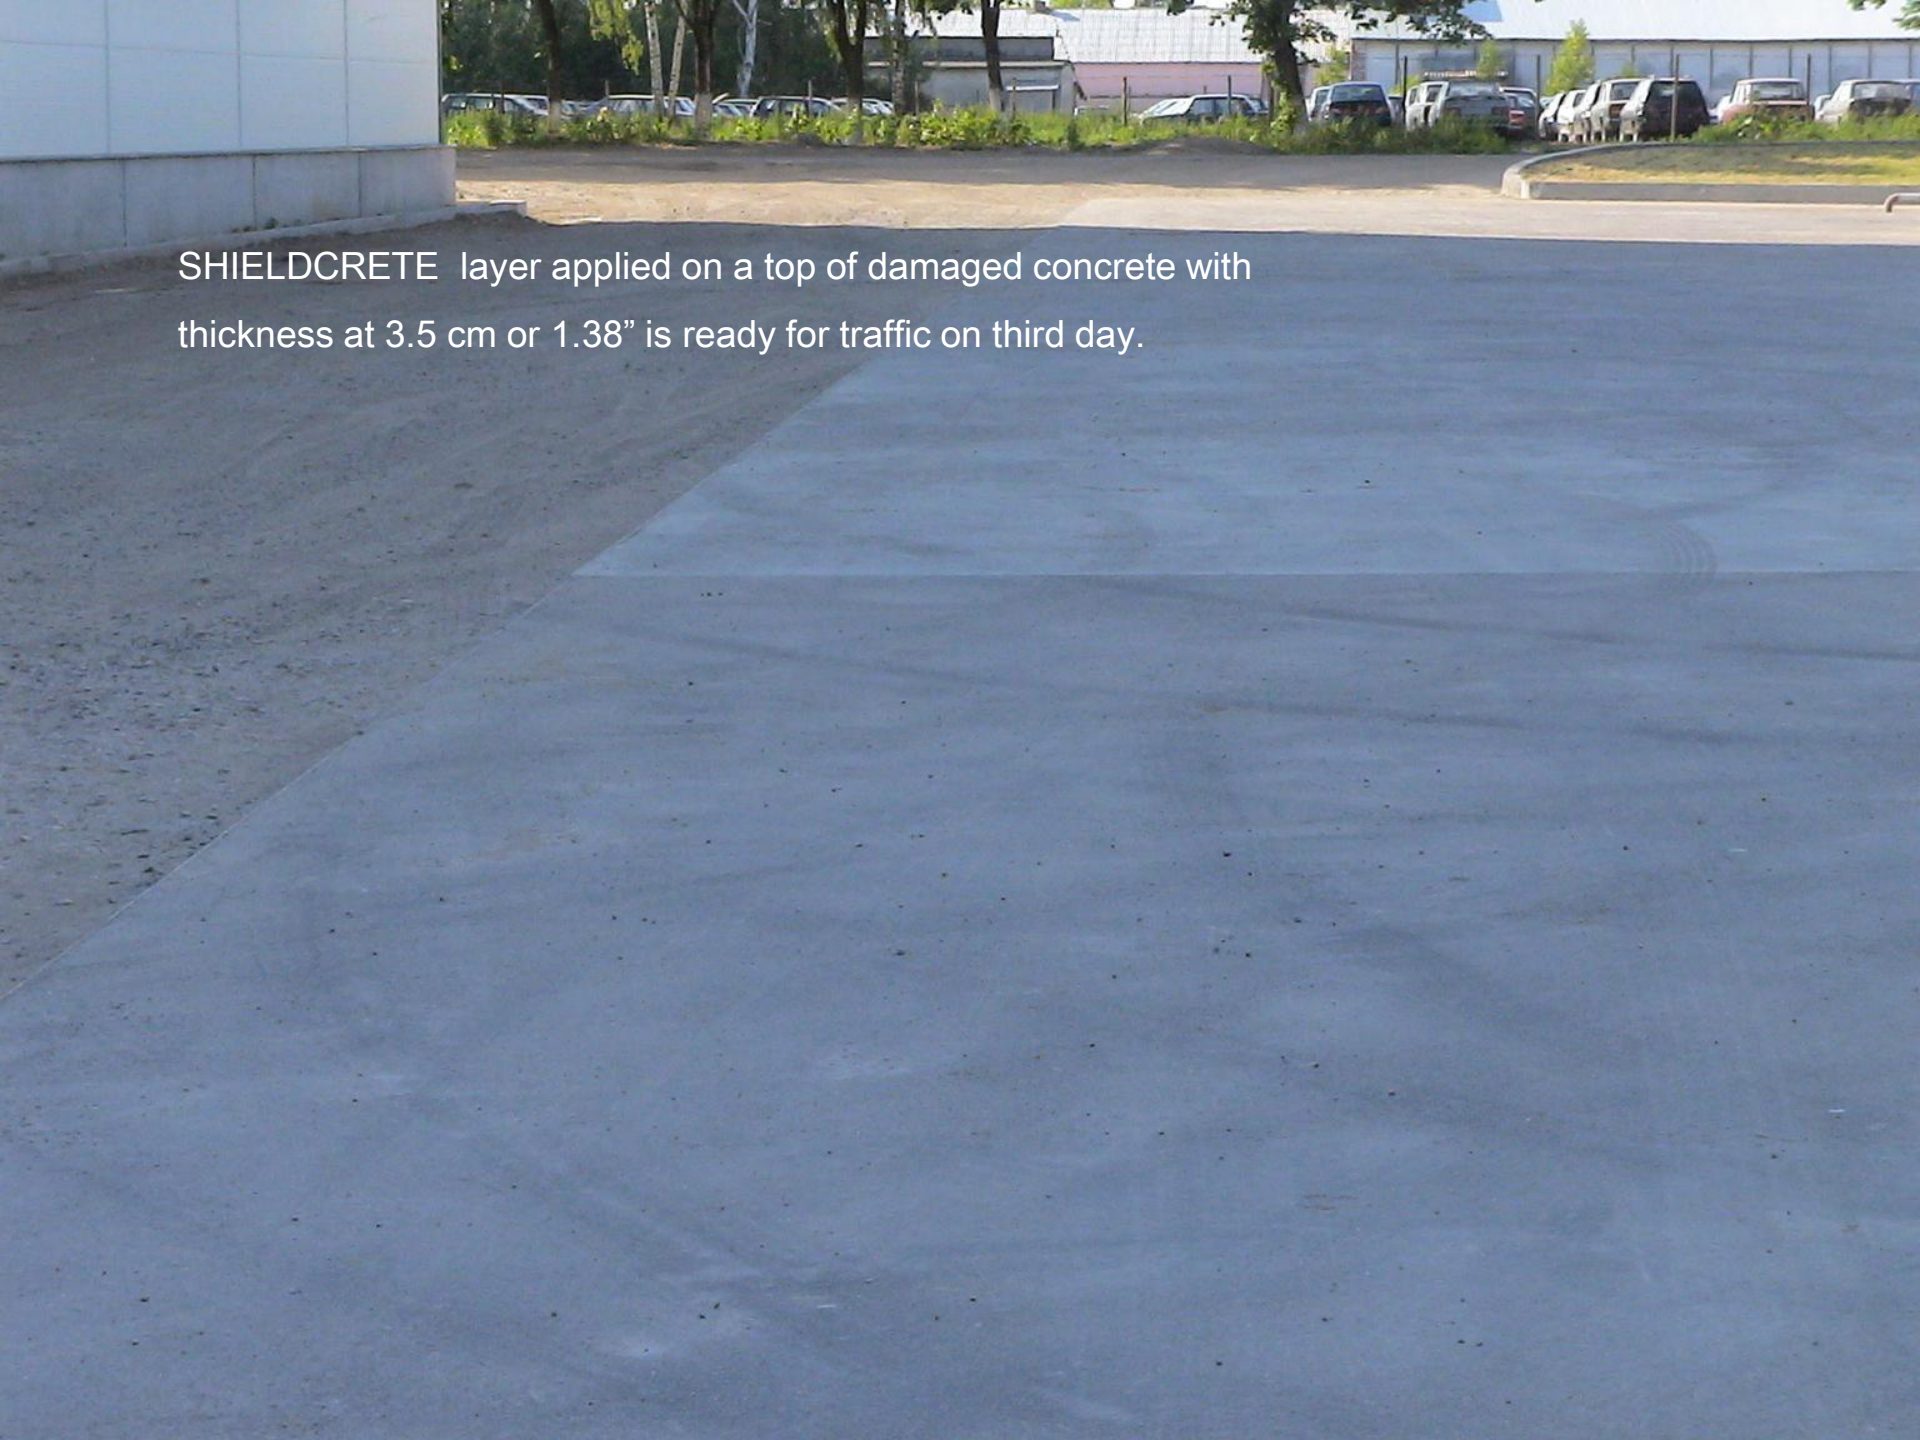
Recent layer of SHIELDCRETE and crumbled surface of to be repaired concrete. Actually, that area was not repaired at that time.

SHIELDCRETE layer applied on a top of damaged concrete with thickness at 3.5 cm or 1.38" is ready for traffic on third day.

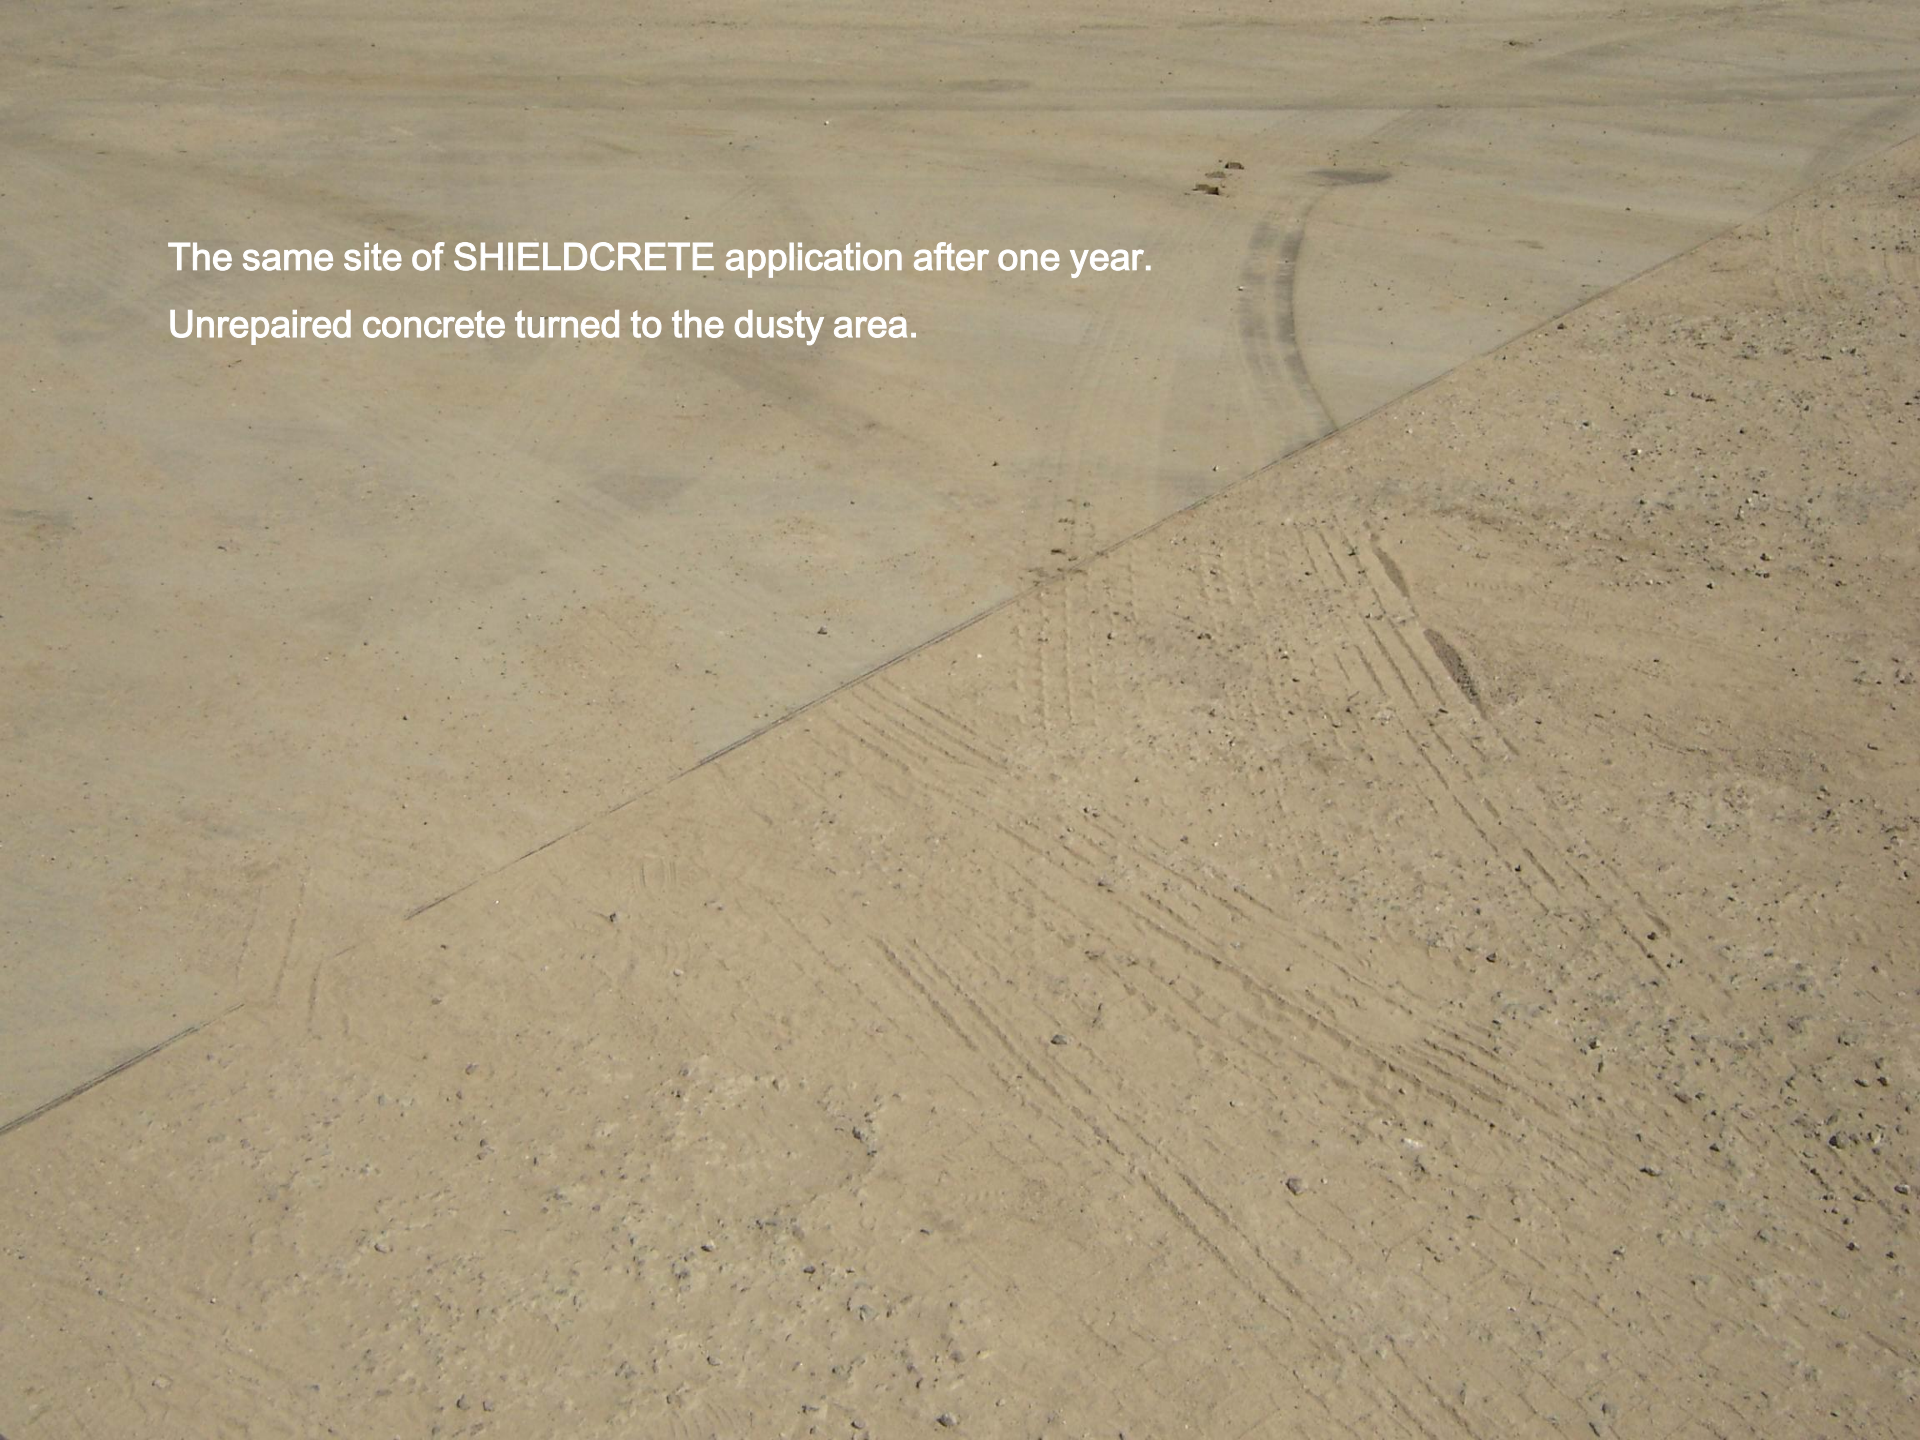
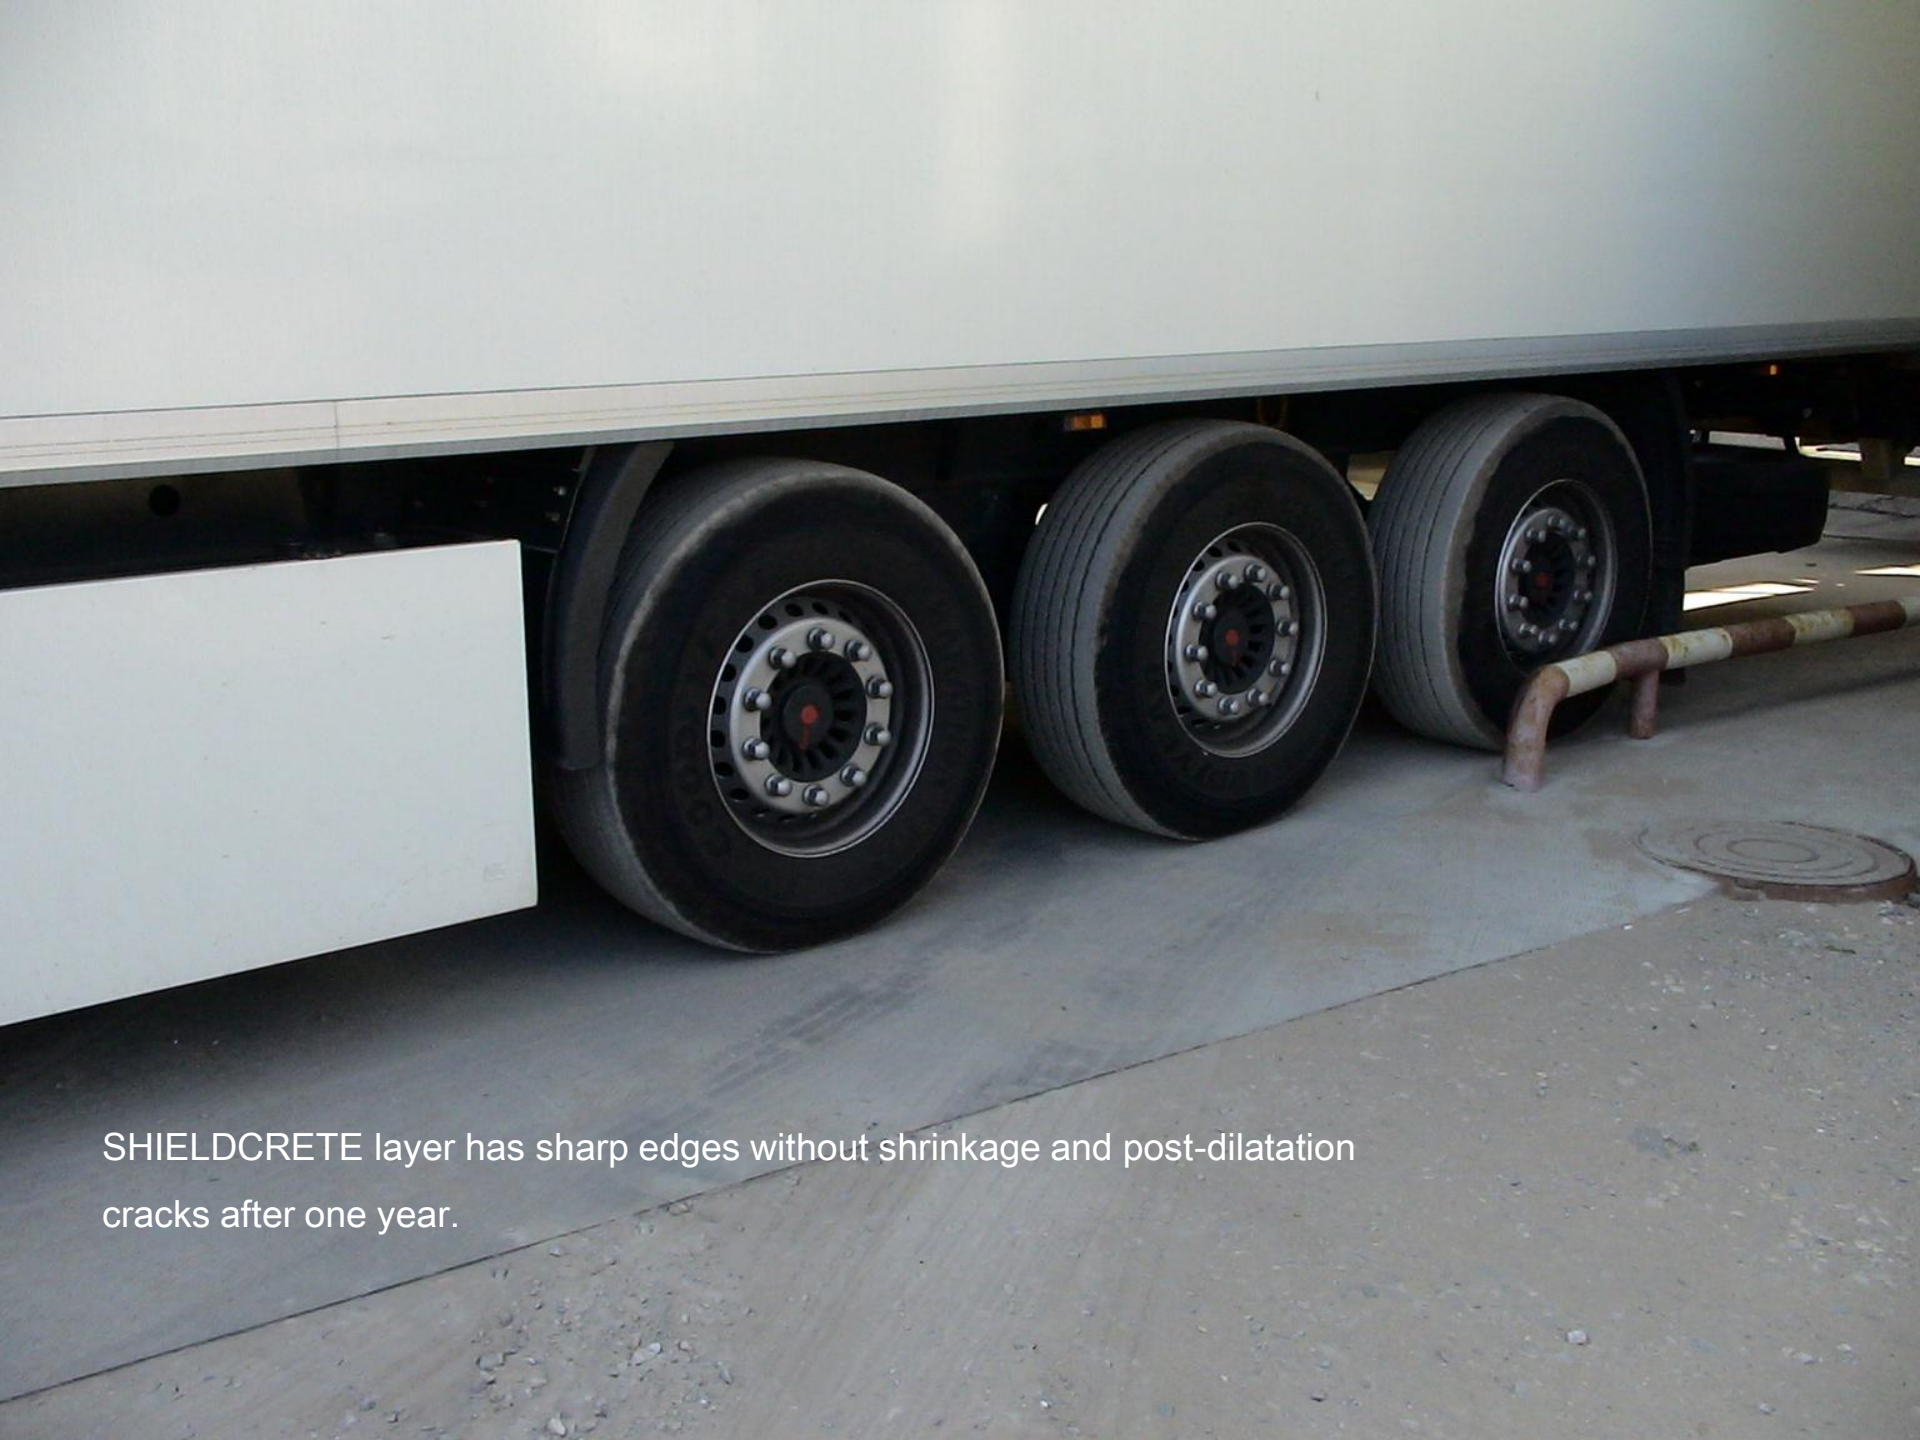
SHIELDCRETE layer has sharp edges without shrinkage and post-dilatation cracks after one year.

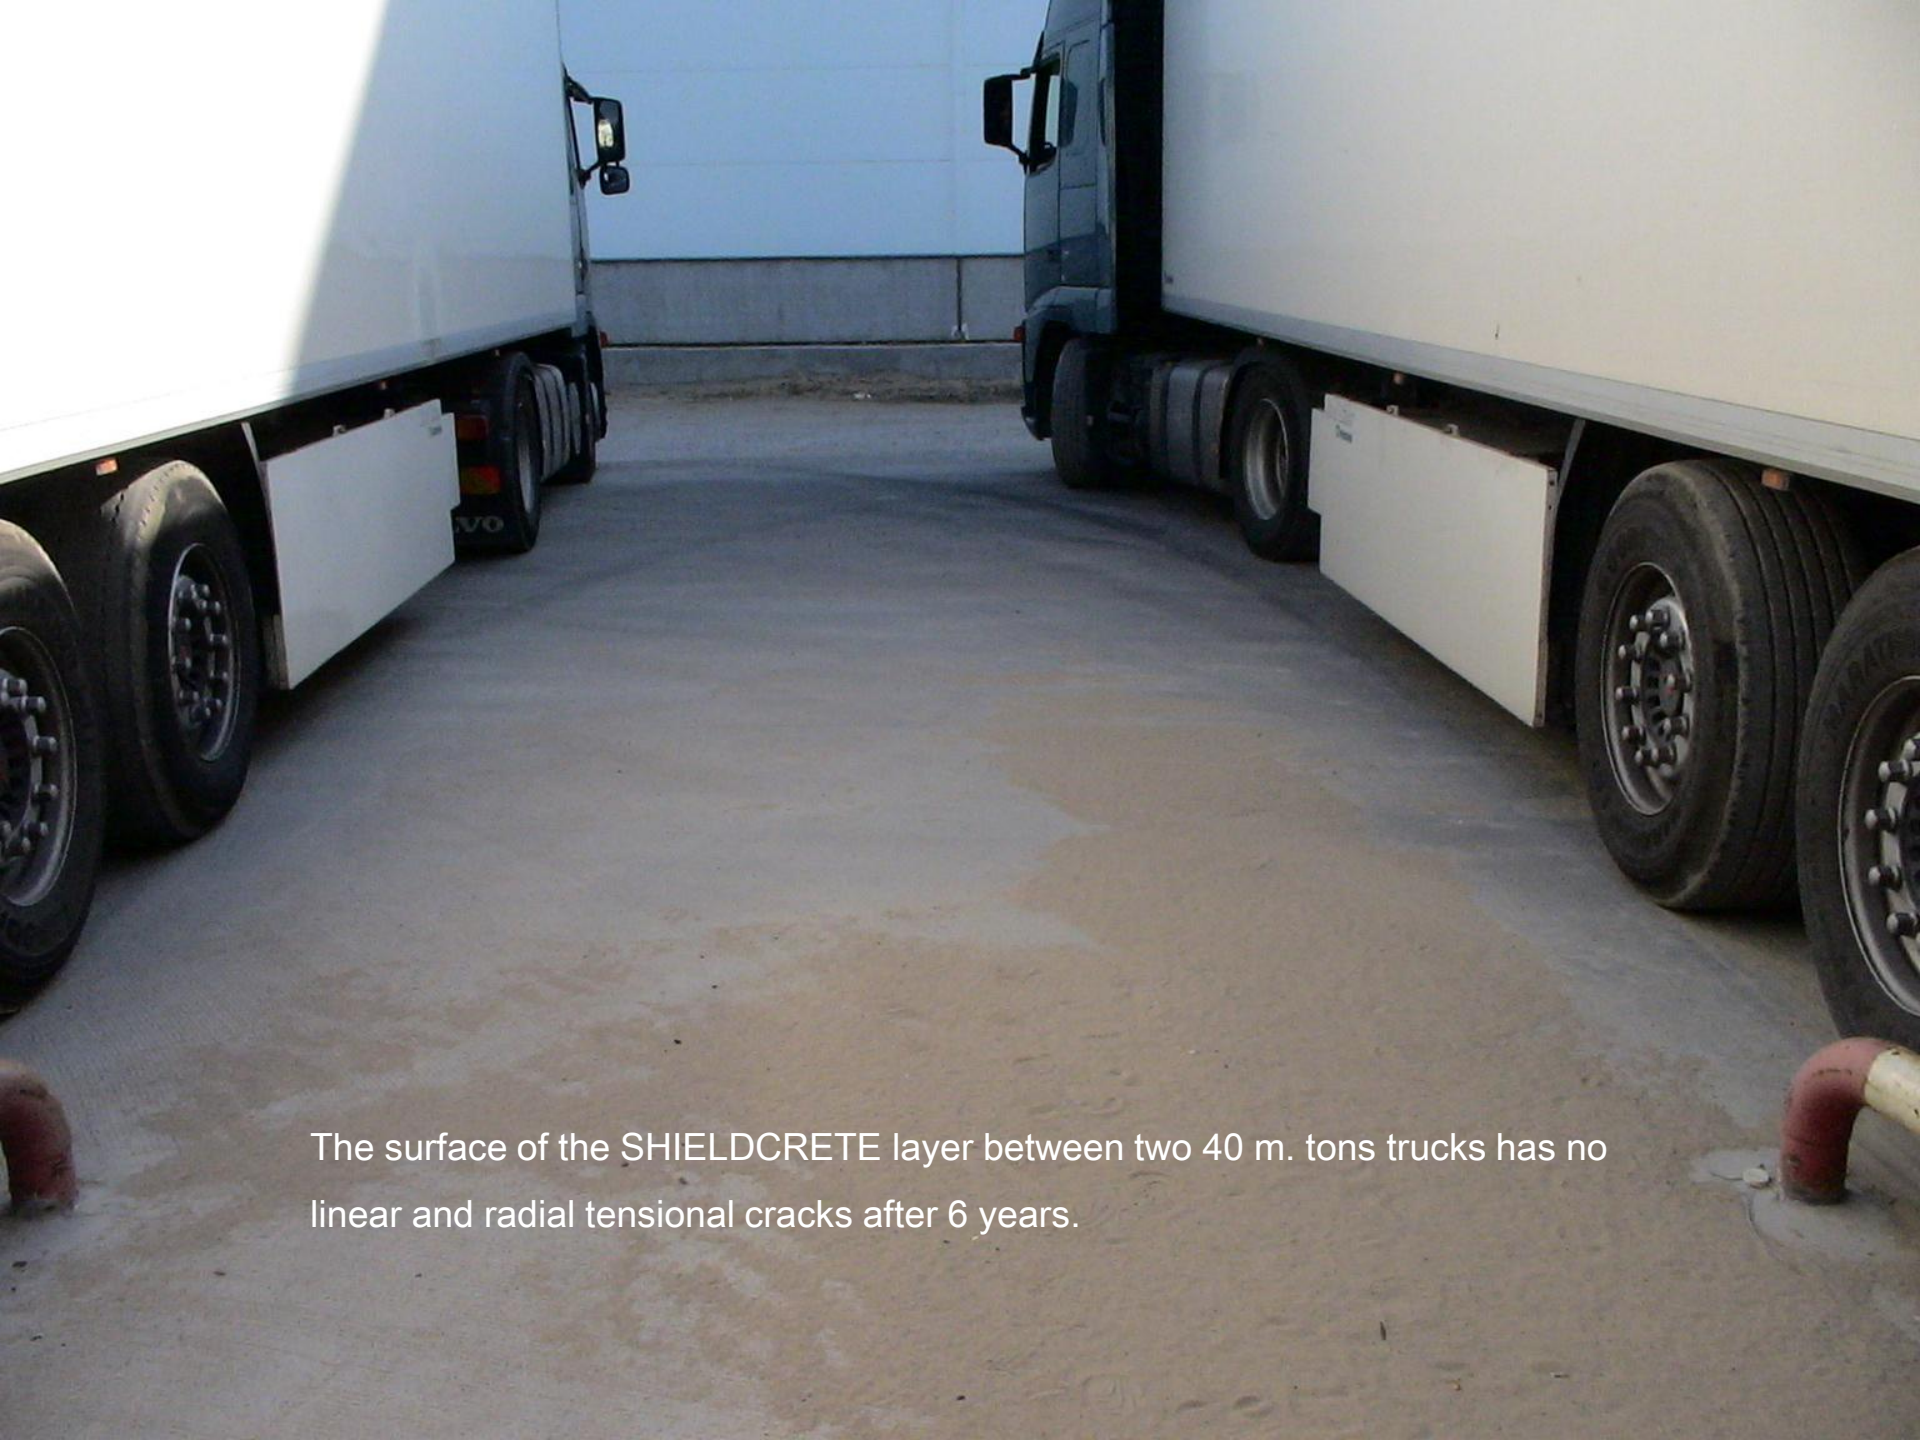
The surface of the SHIELDCRETE layer between two 40 m. tons trucks has no linear and radial tensional cracks after 6 years.

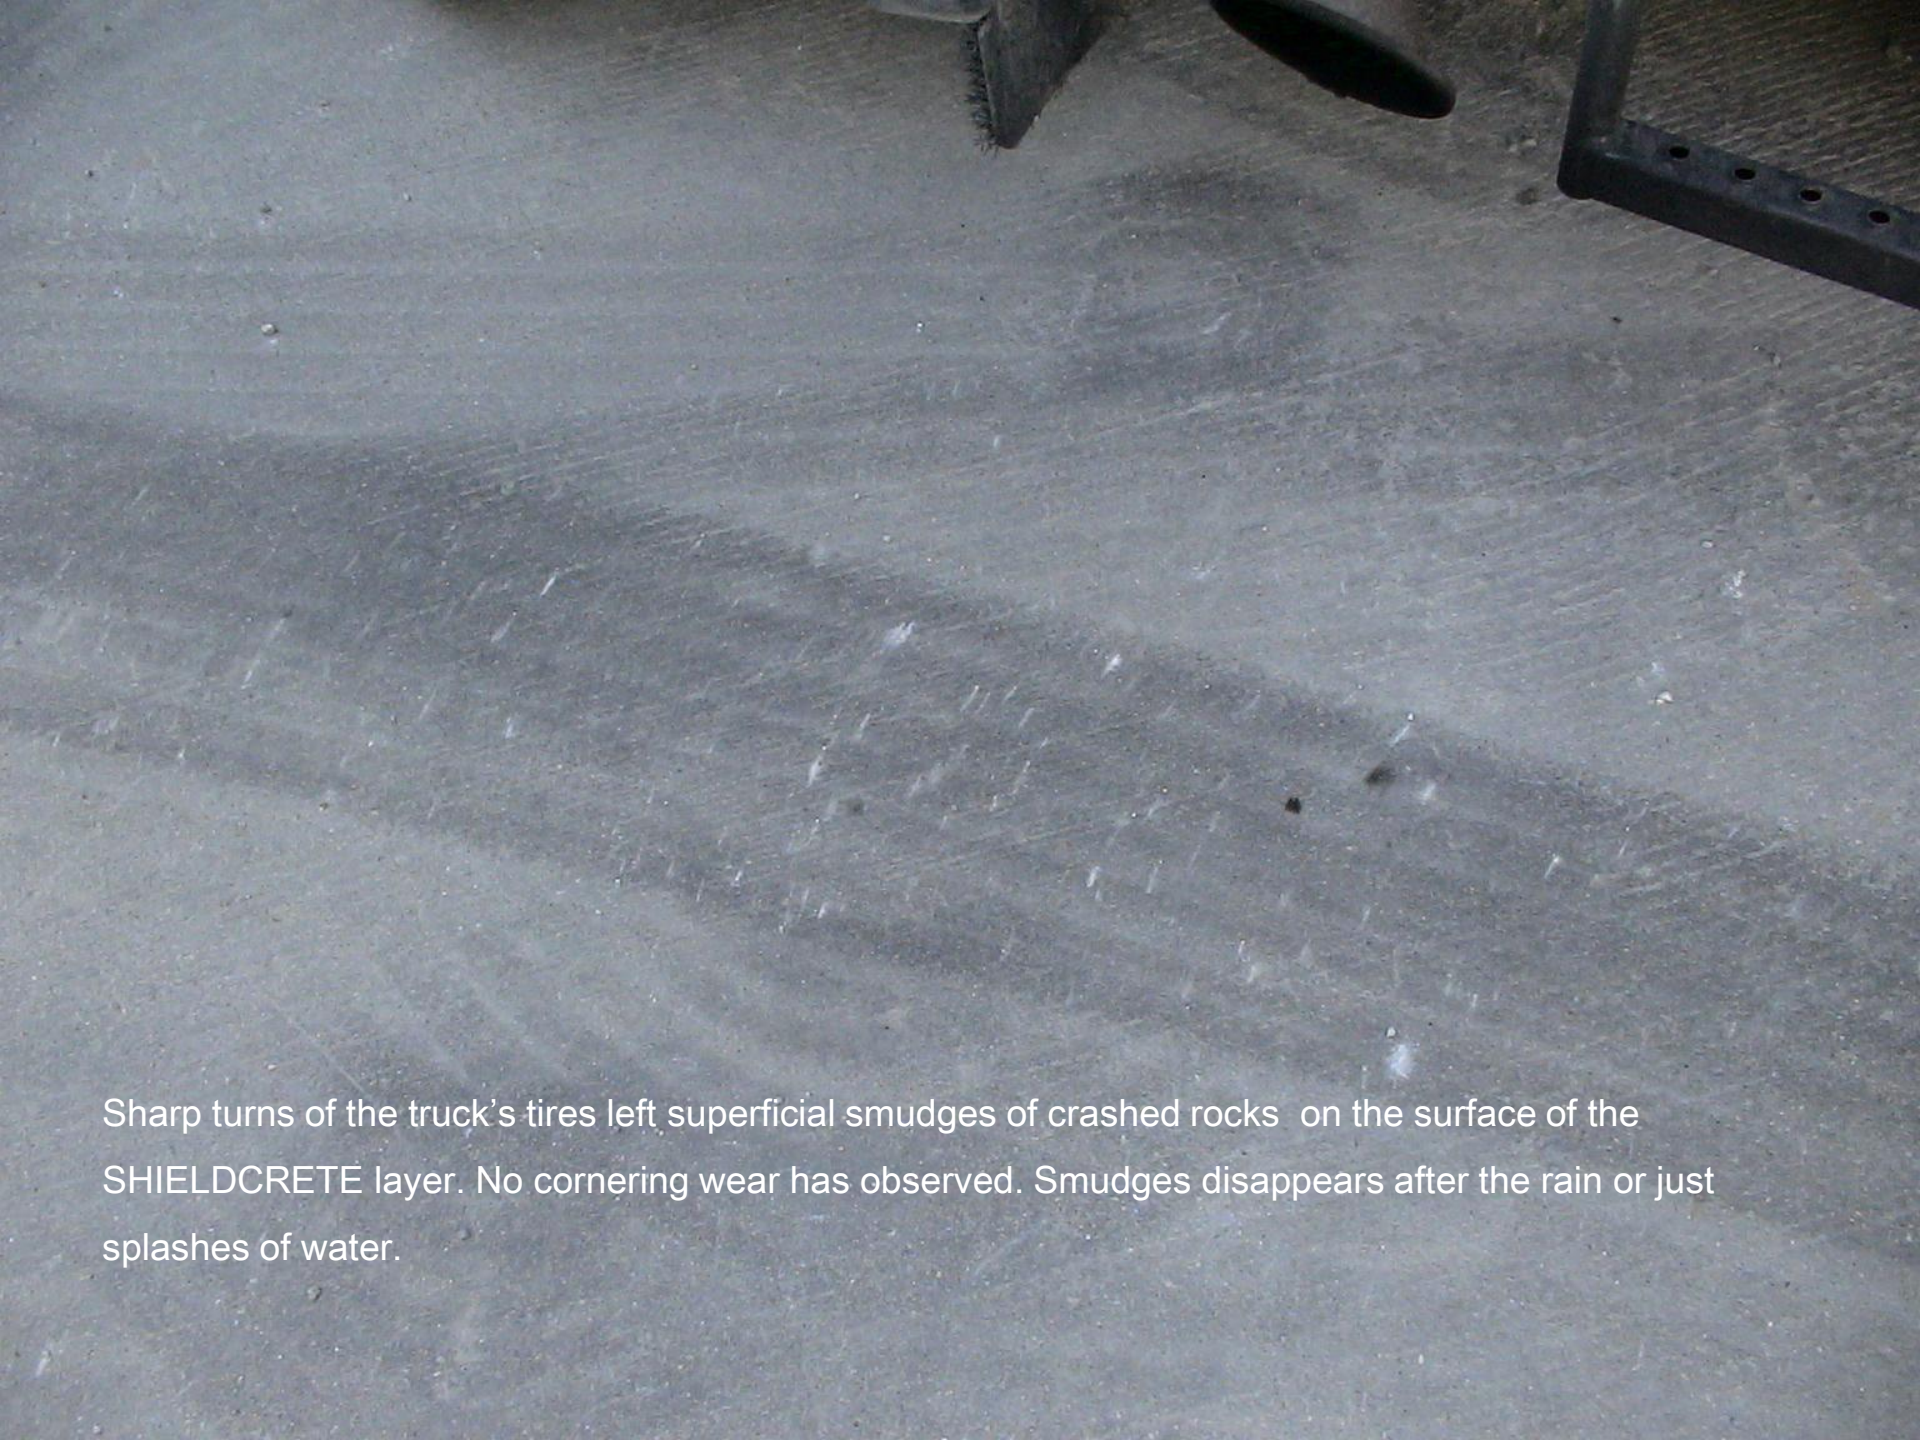
Sharp turns of the truck's tires left superficial smudges of crashed rocks on the surface of the SHIELDCRETE layer. No cornering wear has observed. Smudges disappears after the rain or just splashes of water.
