## **McDONALD'S LOADING YARD IN MOSCOW**

Restoration of concrete loading yard of MacDonald's storage facilities in Moscow by SHIELDCRETE in a year of 2006.

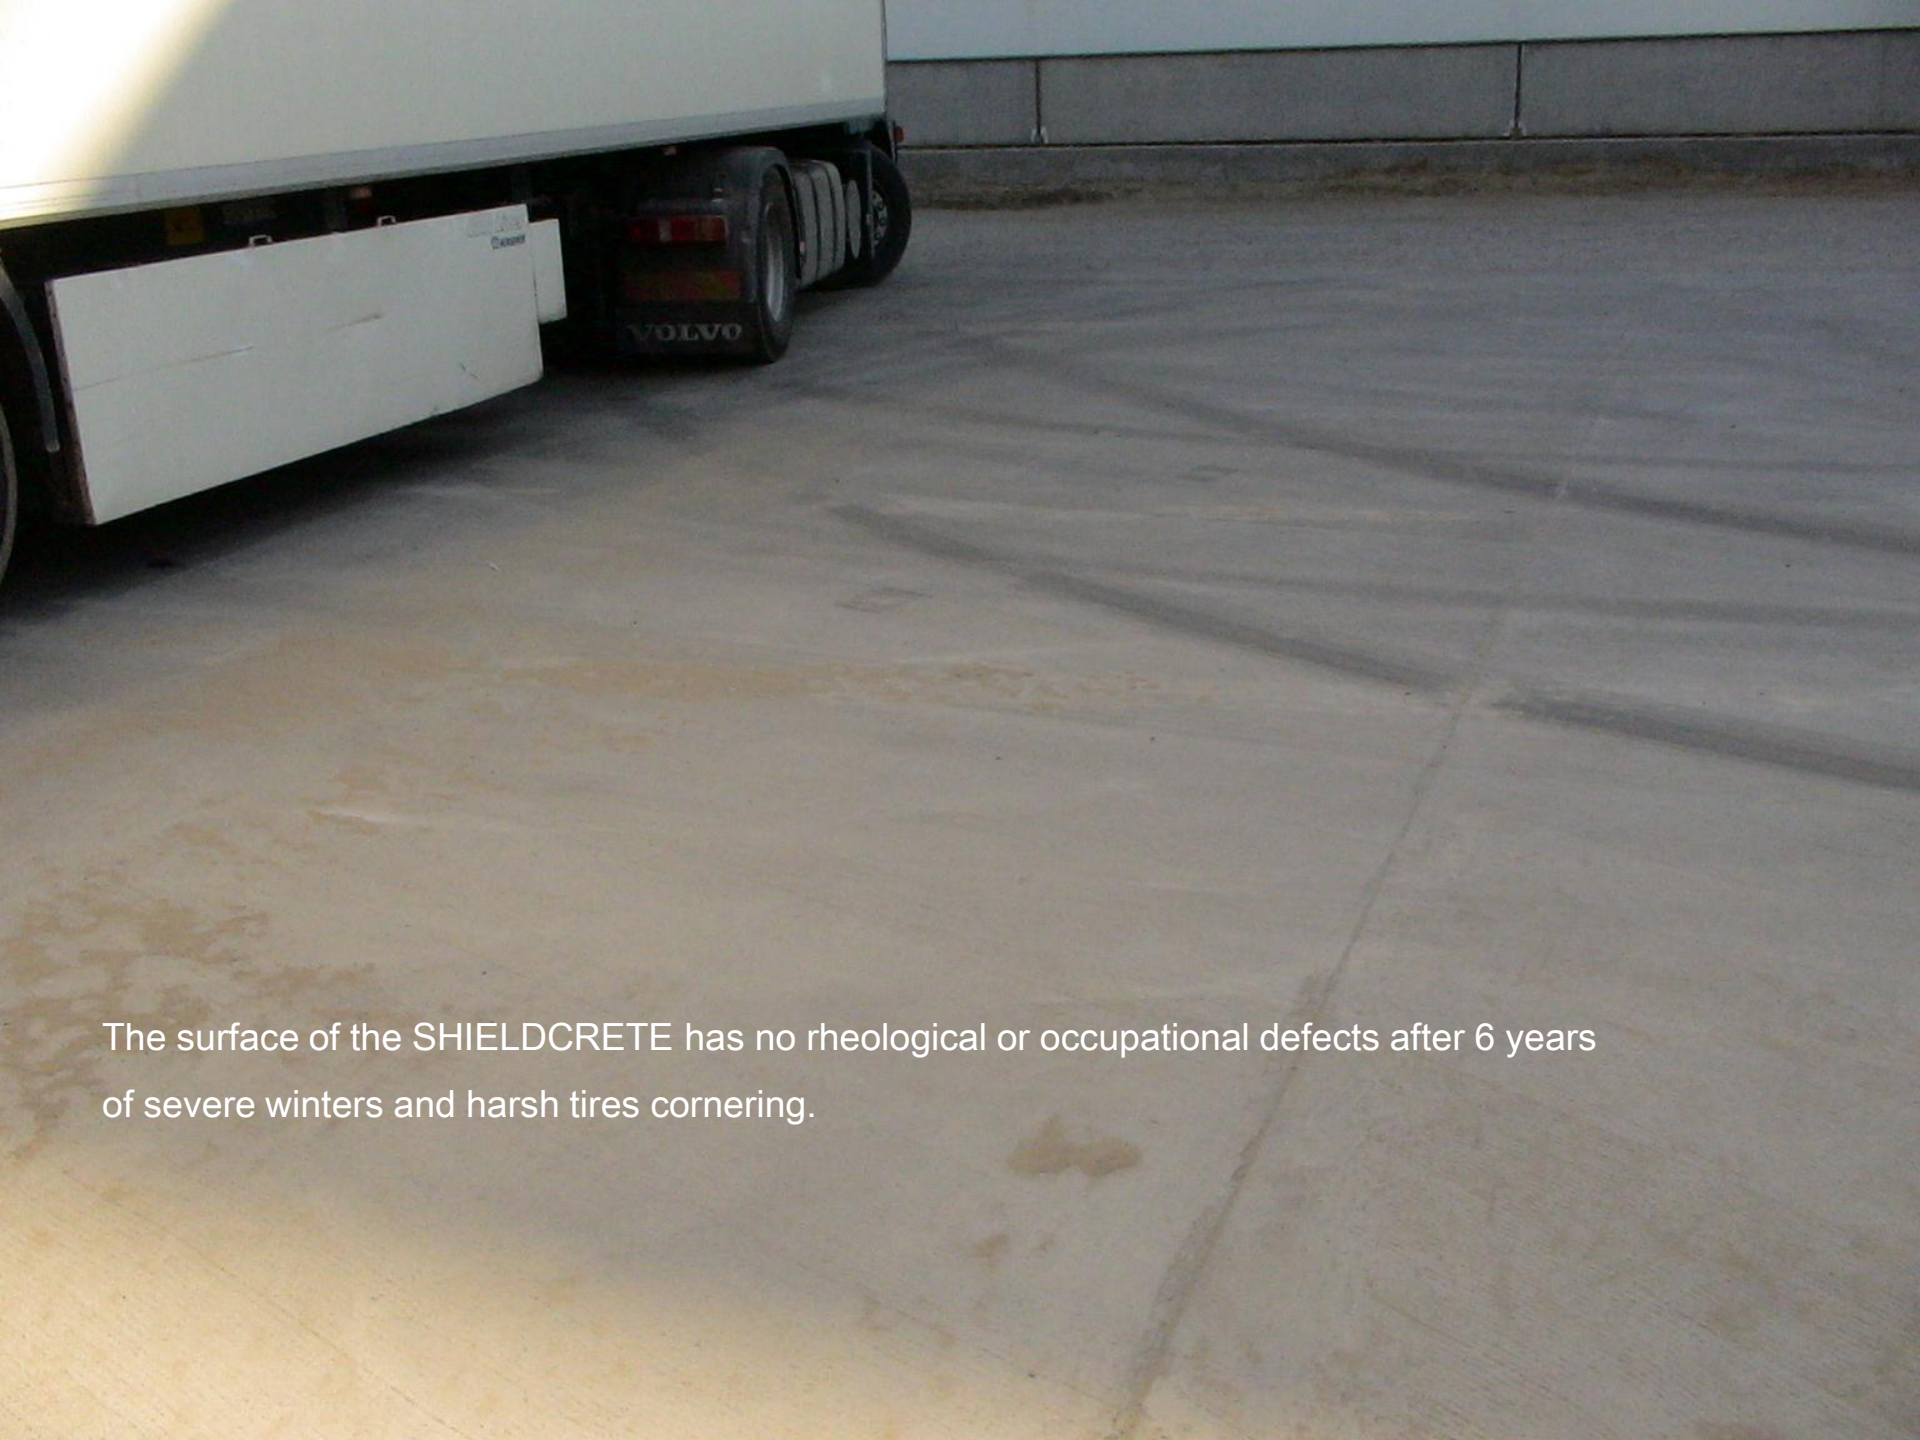
The surface of the SHIELDCRETE has no rheological or occupational defects after 6 years of severe winters and harsh tires cornering.

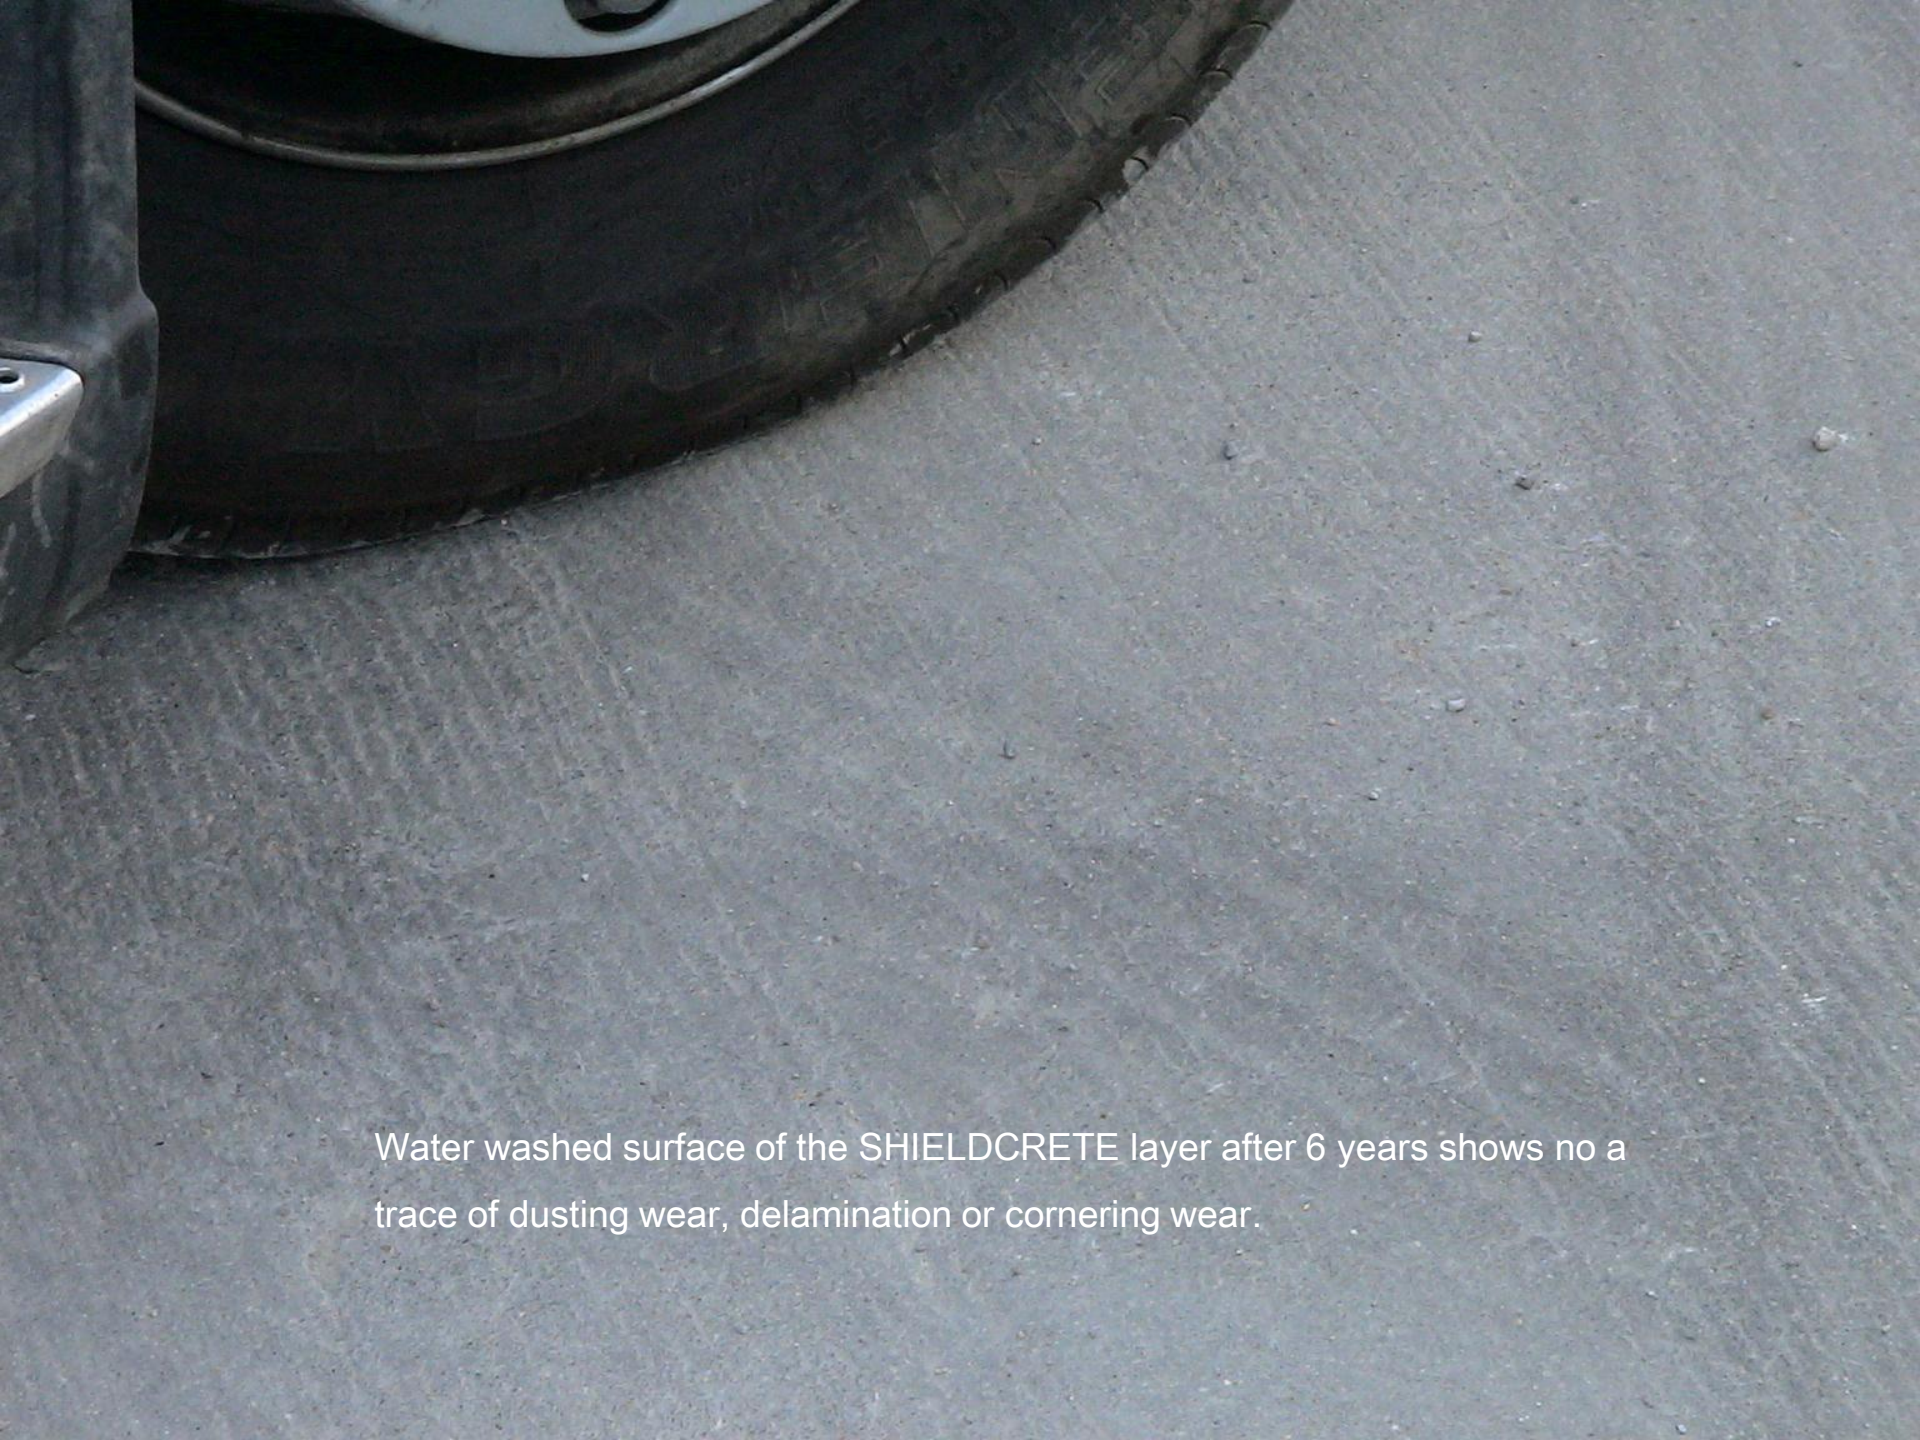
Water washed surface of the SHIELDCRETE layer after 6 years shows no a trace of dusting wear, delamination or cornering wear.
